AN INVESTIGATION OF USING  
AERIAL INFRARED THERMOGRAPHY  
FOR LOCATING SUBSURFACE  
MOISTURE IN BUILT-UP ROOFING

THESIS

Christopher L. Claunch, Captain, USAF

September 1990

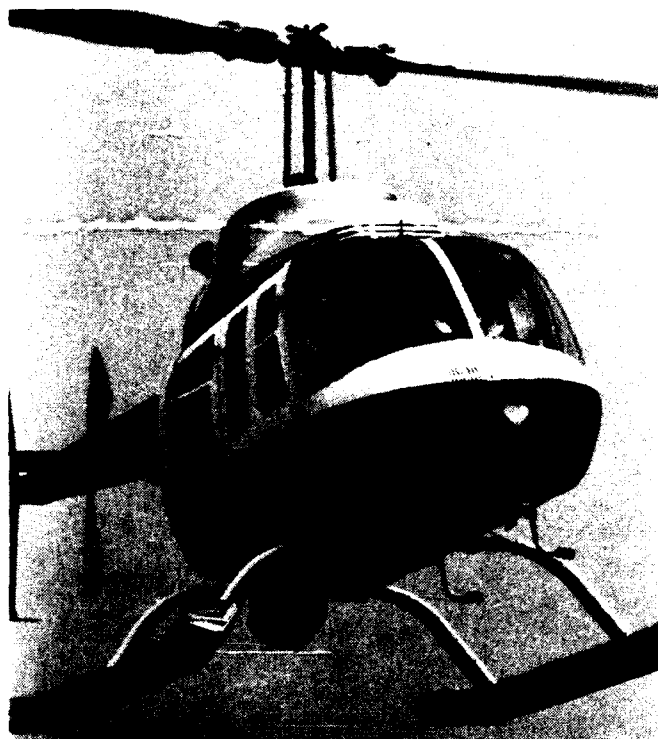
Figure 2. Helicopter with Gimbal Mounted Aerial IR Camera. (Courtesy of ISS Thermographic).

Helicopter vs Fixed-Wing. Some commercial companies use a helicopter for their aerial IR surveys and others use fixed-wing aircraft. The significant advantage of a helicopter is its ability to maneuver closer to a building and thus provide improved resolution. However, its primary disadvantage is its substantially higher cost. Fixed wing aircraft travel faster and are therefore more suitable for surveys located great distances from the IR company's location. According to Jay Vanier of UST, his IR equipment which is mounted on a fixed-wing aircraft has pinpointed moisture spots as small as 6 inches square from 1500 feet above roof level. This resolution is accurate enough for the researcher to conclude that there is not a significant enough difference to limit the focus of this research to helicopter surveys. Since overall cost is a significant element, fixed-wing surveys may be cheaper and in the best interest of the government if the results obtained are adequate.
